EXHIBIT DX3

TO DECLARATION OF PETER J. GOSS IN SUPPORT OF DEFENDANTS' OPPOSITION TO PLAINTIFFS' MOTION TO EXCLUDE THE OPINIONS AND TESTIMONY OF JIM HO, PH.D

Bacillus anthracis Aerosolization Associated with a Contaminated Mail Sorting Machine

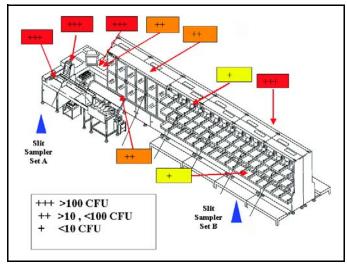
Figure 1. Sites and results of surface sampling for *Bacillus anthracis* with Rodac plates.

Surface sampling was done by two methods, Rodac plates and premoistened swabs, to establish that the machine was still contaminated with viable *B. anthracis* spores. Ten Rodac plate samples and 10 swab samples were taken on the sorter surfaces. Both the Rodac plates and swabs yielded growth of CFUs that were too numerous to count at 7 of the 10 sites. Two additional Rodac plates were positive with low levels of contamination (1 and 3 CFUs); these locations were negative by the swab method (Figure 1).
